**Flood Control Project Maintenance
Levee Inspections**

Maintenance Issue Types Only, Levee Inspection Report By Mile - Spring 2017

Sutter Maintenance Yard Maintenance Area 0001

Waterway	Bank	Unit Miles	Inspection Start/End	Inspector
Unit No. 01 Sacramento River	Right	16.76	03/24/2017 03/24/2017	Bob Duffey

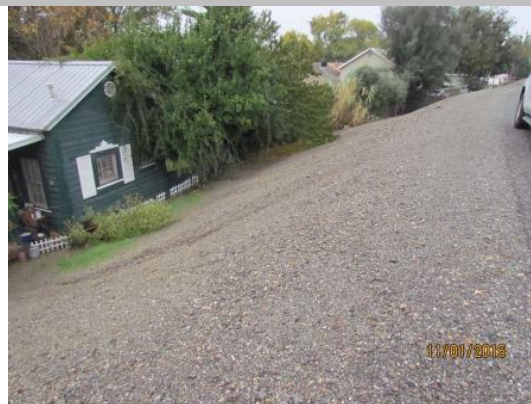
Photo 1 of 1 : SP_2017_MA0001_297_94_20170315_00027.jpg

LM Start	0.09	Rating **	M	Issue No.	94
LM End	0.09	Issue Type +	Ma	Location *	LS
Category	Earthen Levee		GPS Latitude/Longitude		
			Start	End	
Item	Slope Stability		39.214217 °	39.214217 °	
			-122.002378 °	-122.002378 °	
DWR ID	DWR_MA0001_01_f_2016_94				
Comment Code					
S2 : Repair the levee slope damaged by foot traffic and prevent access where possible.					
Inspector Comment					
Repair the erosion along the damaged slope.

View of the slope instability along the landside slope.

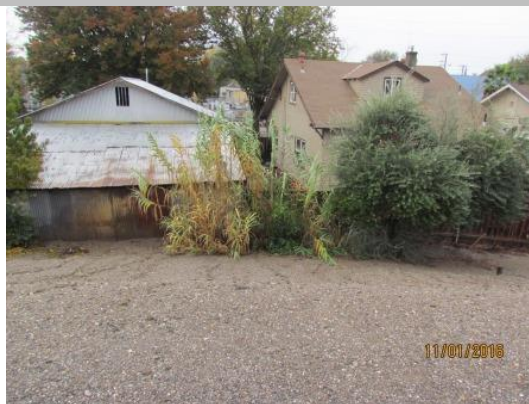
Photo 1 of 1 : SP_2017_MA0001_297_95_20170315_00028.jpg

LM Start	0.10	Rating **	M	Issue No.	95
LM End	0.10	Issue Type +	Ma	Location *	LS
Category	Earthen Levee			GPS Latitude/Longitude	
				Start	End
Item	Vegetation			39.214275 °	39.214275 °
				-122.002558 °	-122.002558 °
DWR ID	DWR_MA0001_01_f_2016_95				
Comment Code					
V2 : Remove the wild growth other than native grasses from the levee slopes.					
Inspector Comment					
Remove the arundo to maintain visibility along the landside toe.

View of the arundo along the landside toe.

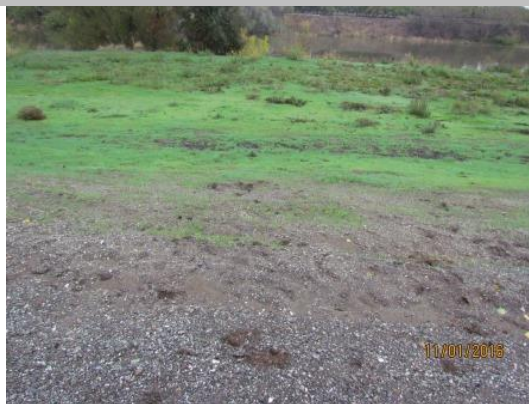
Photo 1 of 1 : SP_2017_MA0001_297_96_20170315_00029.jpg

LM Start	0.23	Rating **	M	Issue No.	96
LM End	0.23	Issue Type +	Ma	Location *	WS
Category	Earthen Levee			GPS Latitude/Longitude	
				Start	End
Item	Erosion / Bank Caving			39.215180 °	39.215180 °
				-122.004712 °	-122.004712 °
DWR ID	DWR_MA0001_01_f_2016_96				
Comment Code					
E2 : Schedule repair of erosion site prior to the next inspection.					
Inspector Comment

View of the erosion along the waterside slope.

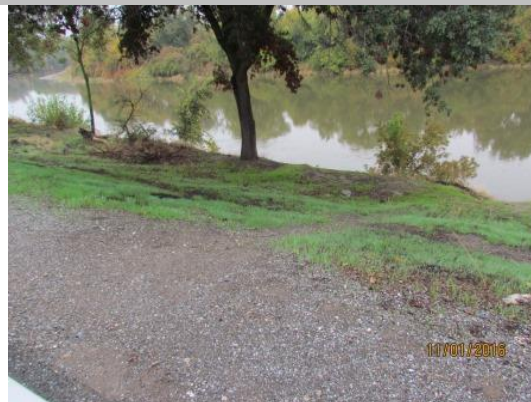
Photo 1 of 1 : SP_2017_MA0001_297_98_20170315_00030.jpg

LM Start	0.38	Rating **	M	Issue No.	98
LM End	0.38	Issue Type +	Ma	Location *	WS
Category	Earthen Levee			GPS Latitude/Longitude	
				Start	End
Item	Slope Stability			39.215878 °	39.215878 °
				-122.007278 °	-122.007278 °
DWR ID	DWR_MA0001_01_f_2016_98				
Comment Code					
S2 : Repair the levee slope damaged by foot traffic and prevent access where possible.					
Inspector Comment

View of the slope instability along the waterside slope.

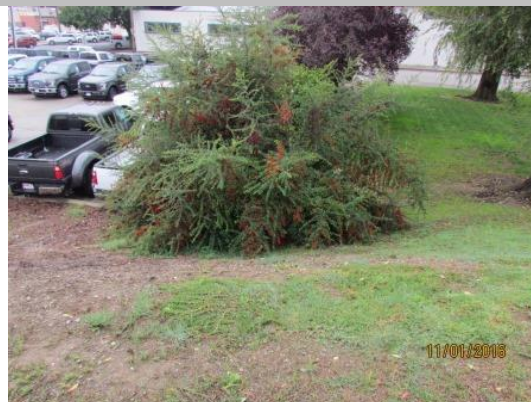
Photo 1 of 1 : SP_2017_MA0001_297_100_20170315_00032.jpg

LM Start	0.49	Rating **	M	Issue No.	100
LM End	0.49	Issue Type +	Ma	Location *	LS
Category	Earthen Levee			GPS Latitude/Longitude	
				Start	End
Item	Trim / Thin Trees			39.215800 °	39.215800 °
				-122.009402 °	-122.009402 °
DWR ID	DWR_MA0001_01_f_2016_100				
Comment Code					
T1 : Trim trees to at least five feet above ground level.					
Inspector Comment

View of an overgrown bush obstructing visibility.

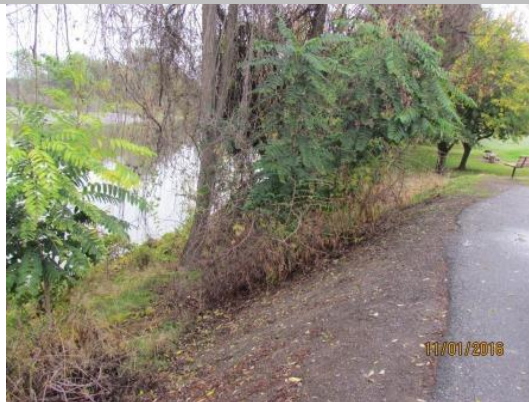
Photo 1 of 1 : SP_2017_MA0001_297_102_20170315_00033.jpg

View of a tree obstructing visibility and access.

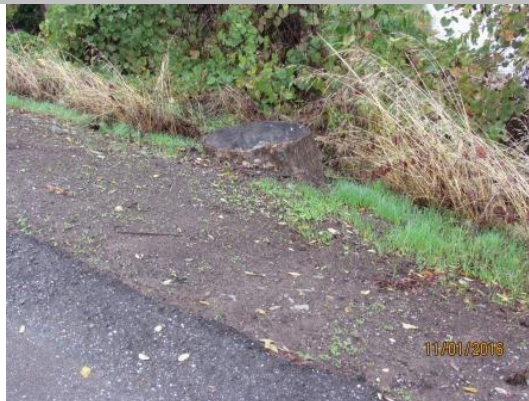
Photo 1 of 1 : SP_2017_MA0001_297_103_20170315_00034.jpg

View of a tree stump along the waterside slope.

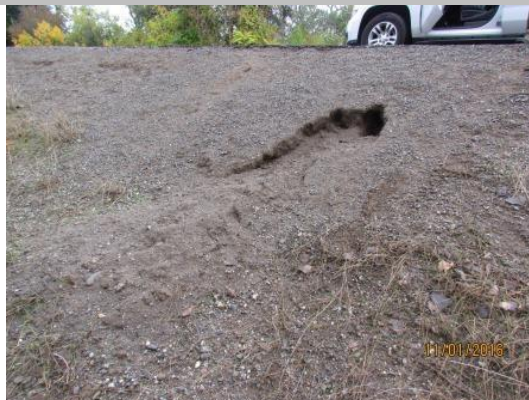
Photo 1 of 1 : SP_2017_MA0001_297_104_20170315_00035.jpg

LM Start	1.11	Rating **	M	Issue No.	104
LM End	1.11	Issue Type +	Ma	Location *	LS
Category	Earthen Levee			GPS Latitude/Longitude	
				Start	End
Item	Slope Stability			39.220728 °	39.220728 °
				-122.015885 °	-122.015885 °
DWR ID	DWR_MA0001_01_f_2016_104				
Comment Code					
S1 : Repair slope instability.					
Inspector Comment

View of a slope instability issue along the landside slope.

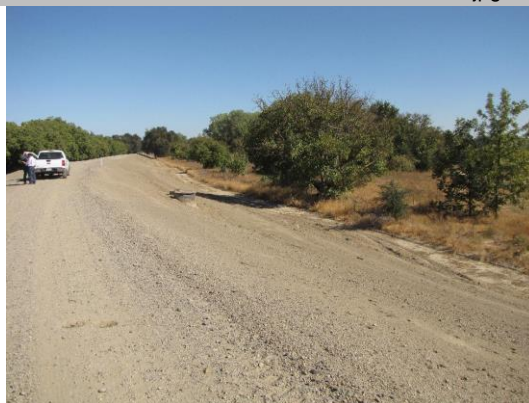
Photo 2 of 3 : UCIP_SP_2017_51852_70063.jpg

FS_ID:51852
DS_ID:16430
EP_NO: 9487
Repair Type: Non-Urgent
Crossing Status: Found
UCIP Comments: 5/3/2017 WS end still partially plugged. (DWR Sutter Yard- A Freitag)10/24/2016 WS end is still partially plugged. (DWR Sutter Yard- A Freitag)4/25/2016 WS pipe end is still plugged with soil. Rest of the pipe appeared to be in good condition.4/20/2015 WS pipe end is plugged about 50% by soil.6/18/2014 Same as last inspection.12/17/2013 Same as last inspection.7/18/2013 WS pipe end has been reformed but is still clogged about 50% by sediment.10/18/2012 Remove dirt and debris in riser. Outlet deformed and blocked over 50%. Debris-round concrete section on landward side. This crossing was listed in the USACE Periodic Inspections as ID# USACE_CESPK_MA1C_2010_p_0116 for crossing outlet deformed and clogged with dirt.
FIELD_STRUCT_DESC: 1 of 2: 36-inch corrugated metal drainage pipe through the levee, approximately 12-15 feet below the crown. Slide gates in corrugated metal pipe (CMP) riser located on the waterside (WS) slope. Pipe daylights on the landside (LS). (Automatic Board Order (ABO) issued as Permit No. 9487, 1974 - Jimeno Rancho)

View of WS looking upstream at CMP riser on slope.

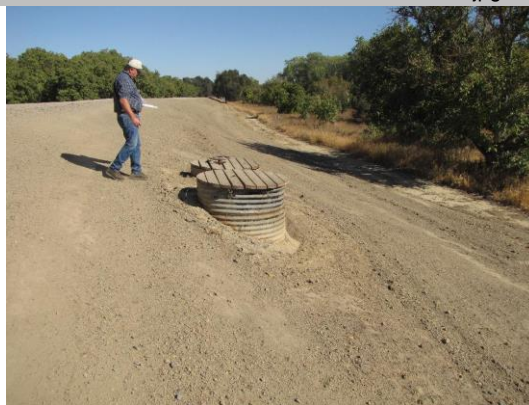
Photo 2 of 3 : UCIP_SP_2017_51853_70074.jpg

View of CMP risers located on WS slope.

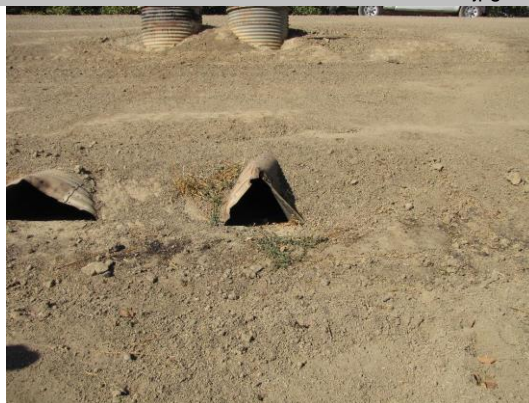
Photo 3 of 3 : UCIP_SP_2017_51853_70073.jpg

FS_ID:51853
DS_ID:17565
EP_NO: 9487
Repair Type: Non-Urgent
Crossing Status: Found
UCIP Comments: 5/3/2017 Ws end still partially plugged. (DWR Sutter Yard- AFreitag)10/24/2016 Ws pipe end still plugged.(DWR Sutter Yard- AFreitag)4/25/2016 WS pipe end still plugged with soil. rest of pipe appears in good condition.4/20/2015 WS pipe end plugged about 50% by soil.6/18/2014 Same as last inspection.12/17/2013 Same as last inspection.7/18/2013 WS pipe end has been reformed but is still partially blocked with dirt and debris.10/18/2012 WS-remove dirt and debris in riser. Outlet deformed and blocked over 50%. Burrow activity near outlet on waterward slope. Debris around concrete section on landward side. This crossing was listed in the USACE Periodic Inspections as ID# USACE_CESPK_MA1C_2010_p_0116 for crossing outlet deformed and clogged with dirt.
FIELD_STRUCT_DESC: 2 of 2: 36-inch corrugated metal drainage pipe through the levee, approximately 12-15 feet below the crown. Slide gates in corrugated metal pipe (CMP) riser on the waterside (WS) slope. Pipe daylights on the landside (LS). (Automatic Board Order (ABO) issued as Permit No. 9487, 1974 - Jimeno Rancho) [Additional Reference(s): DWR Levee Log, 1992. USACE Sacramento O&M Manual 137, August 1955, (Station 103+18)].

CMP pipe outlet deformed with over 50 percent blockage.

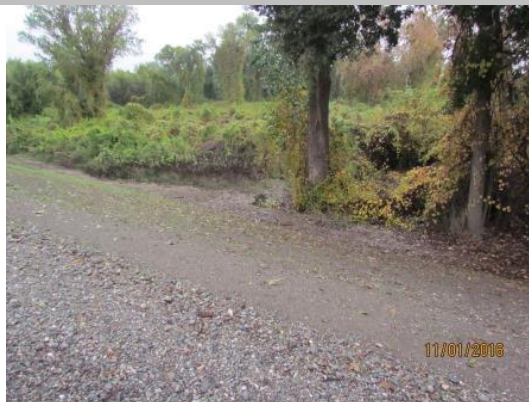
Photo 1 of 1 : SP_2017_MA0001_297_105_20170315_00036.jpg

LM Start	2.16	Rating **	M	Issue No.	105
LM End	2.16	Issue Type +	Ma	Location *	WS
Category	Earthen Levee			GPS Latitude/Longitude	
				Start	End
Item	Erosion / Bank Caving			39.235107 °	39.235107 °
				-122.013567 °	-122.013567 °
DWR ID	DWR_MA0001_01 f _ 2016_105

View of an erosion site along the waterside berm.

E2 : Schedule repair of erosion site prior to the next inspection.

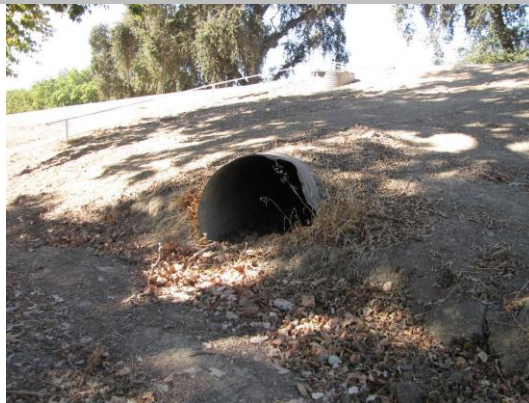
Photo 3 of 3 : UCIP_SP_2017_51854_70077.jpg

FS_ID:51854
DS_ID:16429
EP_NO: 9472
Repair Type: Non-Urgent
Crossing Status: Found
UCIP Comments: 5/3/2017 LS inlet partially plugged with soil. Some debris still present inside riser. (DWR Sutter Yard-AFreitag)10/24/2016 Debris still inside of riser.(DWR Sutter Yard-AFreitag)4/25/2016 Pipe still inside of riser and LS end plugged about 50% by soil.4/20/2015 Same as last inspection.6/18/2014 Same as last inspection.12/17/2013 Same as last inspection.7/18/2013 Same as last inspection.10/18/12 Remove debris from riser. Landward inlet is blocked by over 50%. This crossing was listed in the USACE Periodic Inspections as ID# USACE_CESPK_MA1C_2010_p_0128 for sediment build up at inlet (landward side) and debris inside riser. FIELD_STRUCT_DESC: 54-inch corrugated metal drainage pipe through the levee, approximately 12-15 feet below the crown. Slide gate in corrugated metal pipe (CMP) riser on the waterside (WS) slope. 48-inch CMP at landside (LS) slope. This crossing crosses the levee at an angle. (Automatic Board Order (ABO) issued as Permit No. 9472, 1974 - Ballard)) [Additional Reference(s): DWR Levee Log, 1992. USACE Sacramento O&M Manual 137, August 1955, (Station 120+00)]. FS Date: 5/19/2017 1:23:34 PM

View of outlet located at WS toe.

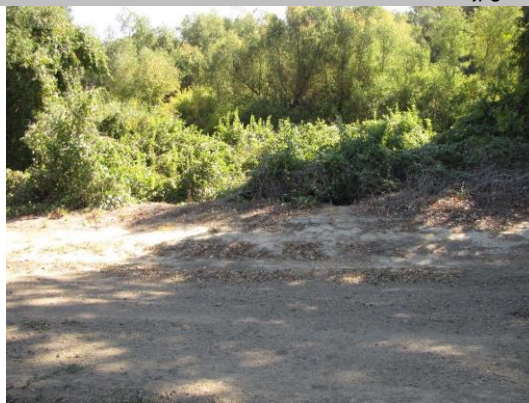
Photo 3 of 3 : UCIP_SP_2017_51855_70083.jpg

FS_ID:51855
DS_ID:16428
EP_NO: 9467
Repair Type: Non-Urgent
Crossing Status: Found
UCIP Comments: 5/3/2017 Abandoned- needs to be done so properly. (DWR Sutter Yard- A Freitag)10/24/2016 Abandoned.(DWR Sutter Yard- A Freitag)4/25/2016 Abandoned crossing. Unable to locate any WS and LS pipe ends.4/20/2015 Same as last inspection.6/18/2014 Same as last inspection.12/17/2013 Same as last inspection.7/18/2013 Same as last inspection.10/18/2012 Only riser visible. Debris and sediment blocking gate. Gate inside riser is buried and non-functional. If crossing is abandoned, owner needs to properly abandon. This crossing was listed in the USACE Periodic Inspections as ID# USACE_CESPK_MA1C_2010_p_0132 no culvert through the levee is visible here.
FIELD_STRUCT_DESC: *ABANDONED* 24-inch corrugated metal drainage pipe through the levee, approximately 12-15 feet below the crown. Slide gate in CM pipe riser on the waterside (WS) slope. No signs of inlet visible on the landside (LS). (Automatic Board Order (ABO) issued as Permit No. 9467, 1974 - Lovell E. Spurgeon)

Unable to locate WS outlet.

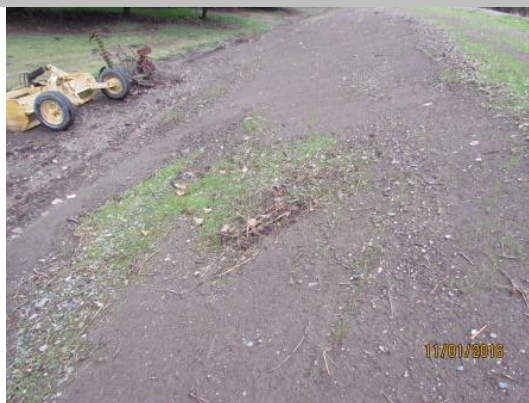
Photo 1 of 1 : SP_2017_MA0001_297_108_20170315_00040.jpg

LM Start	2.36	Rating **	M	Issue No.	108
LM End	2.36	Issue Type +	Ma	Location *	LS
Category	Earthen Levee		GPS Latitude/Longitude		
			Start	End	
Item	Slope Stability		39.237628 °	39.237628 °	
			-122.011967 °	-122.011967 °	
DWR ID	DWR_MA0001_01_f_2016_108

View of the slope instability along the landside slope.

S1 : Repair slope instability.

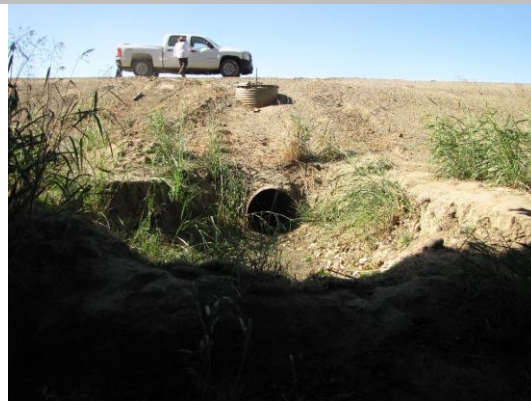
Photo 3 of 3 : UCIP_SP_2017_51859_70111.jpg

FS_ID:51859
DS_ID:16426
EP_NO: 9490
Repair Type: Non-Urgent
Crossing Status: Found
UCIP Comments: 5/3/2017 Sediment build up in WS pipe end. WS slide gate stem bent but it does not affect its operation. (DWR Sutter Yard- A Freitag)10/24/2016 WS slide gate stem is still bent.(DWR Sutter Yard- A Freitag)4/25/2016 WS slide gate is slightly bent. Rest of crossing appears to be in good condition. 4/20/2015 LS inlet still has some minor sediment build up. Needs to be cleaned.6/18/2014 Same as last inspection.12/17/2013 Same as last inspection.7/18/2013 WS slide gate looks to be in good condition but stem is slightly bent. Not sure if bend will hinder gates operation or not. LS inlet is still blocked by minor sediment build up.10/18/2012 LS pipe slightly deformed and sediment build up blocking about 30% of opening; need to check the condition of the slide gate-need photo. Metal marker down. This crossing was listed in the USACE Periodic Inspection as ID# USACE_CESPK_MA1C_2010_p_0187 for sediment build up at landward toe.

View of WS slope, riser with slide gate, and outlet.

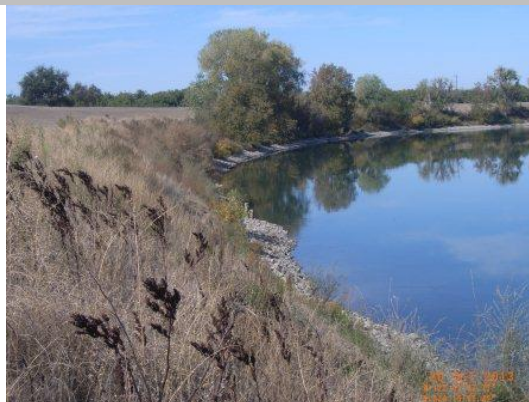
Photo 1 of 1 : SP_2017_MA0001_297_3_20170315_00002.jpg

LM Start	4.86	Rating **	M	Issue No.	3
LM End	5.26	Issue Type +	Ma	Location *	WS
Category	Supplemental			GPS Latitude/Longitude	
				Start	End
Item	2015 USACE Erosion Survey, DRAFT			39.265730 °	39.266315 °
				-122.014925 °	-122.020682 °
DWR ID	DWR_MA0001_01_s_2016_3				
Comment Code					
Inspector Comment					
2009 - Slump in the middle of the section has left a vertical section on the bank. 2010 - Old cobble site unraveling, site extended downstream. 2015: Last observed in 2013. [2015 Site ID: SAC_151-0_R]

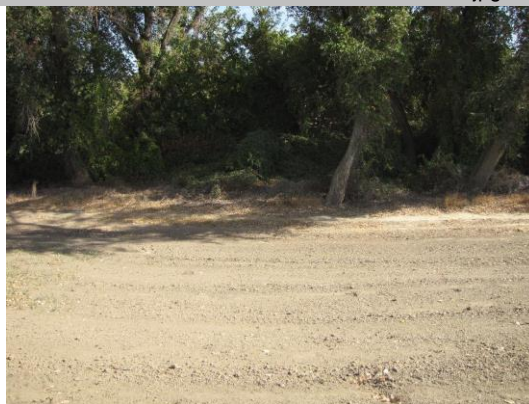
Photo 1 of 3 : UCIP_SP_2017_51874_70181.jpg

FS_ID:51874
DS_ID:16425
EP_NO: N/A
Repair Type: Non-Urgent
Crossing Status: Found
UCIP Comments: 5/3/2017 Abandoned- needs to be done properly.
(DWR Sutter Yard- A Freitag)10/24/2016 Abandoned(DWR Sutter Yard- A Freitag)4/25/2016 Abandoned crossing.4/20/2015 Same as last inspection.6/23/2014 Same as last inspection.12/17/2013 Same as last inspection.7/18/2013 Same as last inspection.10/19/2012 Need to be properly abandoned concrete structure; plate covers concrete box; Concrete headwall damaged. This crossing was listed in the USACE Periodic Inspection as ID# USACE_CESPK_MA1C_2010_p_0262 for damage to concrete structure (vertical 2 inch wide cracks and spalling visible).
FIELD_STRUCT_DESC: *ABANDONED* 72-inch corrugated metal (precast concrete) drainage pipe through the levee at an unknown depth below the crown. Structure is blocked on the waterside (WS) end with 3-foot concrete plug installed in 1980. Slide gate in concrete well on the landside (LS) shoulder. Concrete headwall at both toes. WS headwall not found. [Additional Reference(s): DWR Levee Log, 1992. USACE Sacramento O&M Manual 137, August 1955, (Station 339+74)].

View of WS no structure features visible.

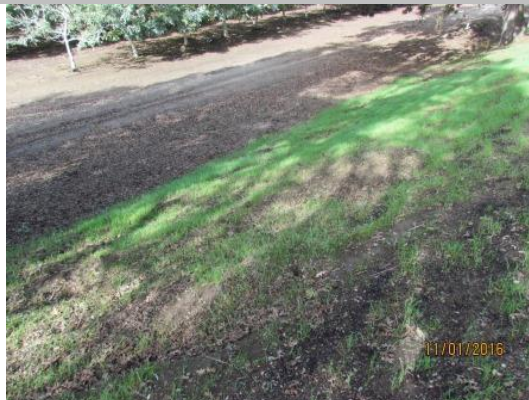
Photo 1 of 1 : SP_2017_MA0001_297_119_20170315_00048.jpg

LM Start	8.72	Rating **	M	Issue No.	119
LM End	8.72	Issue Type +	Ma	Location *	LS
Category	Earthen Levee			GPS Latitude/Longitude	
				Start	End
Item	Slope Stability			39.308272 °	39.308272 °
				-122.031215 °	-122.031215 °
DWR ID	DWR_MA0001_01_f_2016_119				
Comment Code					
S3 : Repair the levee slope damaged by vehicle traffic and prevent access where possible.					
Inspector Comment

View of the slope instability caused by vehicles along the landside slope.

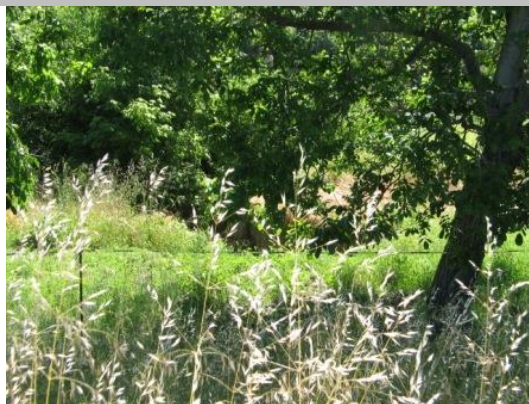
Photo 1 of 1 : SP_2017_MA0001_297_18_20170315_00010.jpg

View of the erosion along the waterside of the levee.

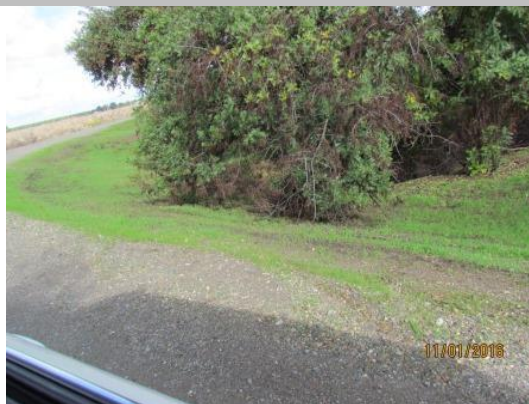
Photo 1 of 1 : SP_2017_MA0001_297_120_20170315_00049.jpg

LM Start	11.00	Rating **	M	Issue No.	120
LM End	11.00	Issue Type +	Ma	Location *	WS
Category	Earthen Levee			GPS Latitude/Longitude	
				Start	End
Item	Trim / Thin Trees			39.340728 °	39.340728 °
				-122.032897 °	-122.032897 °
DWR ID	DWR_MA0001_01_f_2016_120				
Comment Code					
T1 : Trim trees to at least five feet above ground level.					
Inspector Comment

View of the tree with overhanging branches.

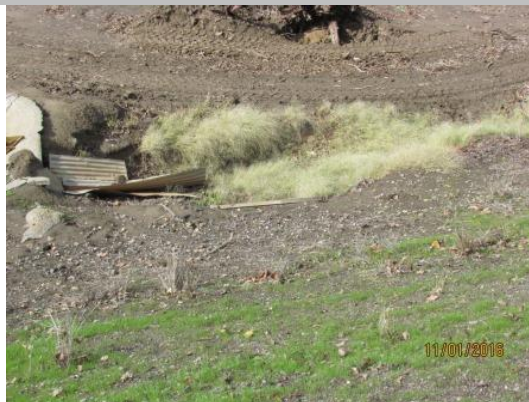
Photo 1 of 1 : SP_2017_MA0001_297_121_20170315_00050.jpg

LM Start	11.46	Rating **	M	Issue No.	121
LM End	11.46	Issue Type +	Ma	Location *	LS
Category	Earthen Levee			GPS Latitude/Longitude	
				Start	End
Item	Slope Stability			39.347168 °	39.347168 °
				-122.031533 °	-122.031533 °
DWR ID	DWR_MA0001_01_f_2016_121				
Comment Code					
S1 : Repair slope instability.					
Inspector Comment					
Backfill and compact.

View of the low spot along the levee toe created by adjacent ditch overflow.

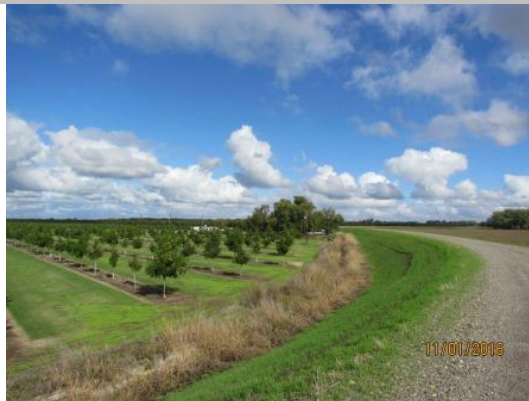
Photo 1 of 1 : SP_2017_MA0001_297_122_20170315_00051.jpg

View of the Johnson grass along the levee toe and concrete lined ditch.

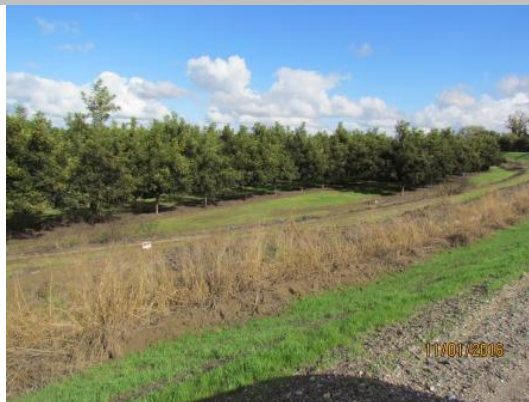
Photo 1 of 1 : SP_2017_MA0001_297_123_20170315_00052.jpg

LM Start	12.69	Rating **	M	Issue No.	123
LM End	12.79	Issue Type +	Ma	Location *	LS
Category	Earthen Levee			GPS Latitude/Longitude	
				Start	End
Item	Vegetation			39.359810 °	39.359748 °
				-122.019402 °	-122.017600 °
DWR ID	DWR_MA0001_01_f_2016_123				
Comment Code					
V1 : Control annual grass and weeds on the levee slopes and easements.					
Inspector Comment

View of the Johnson grass along the levee toe.

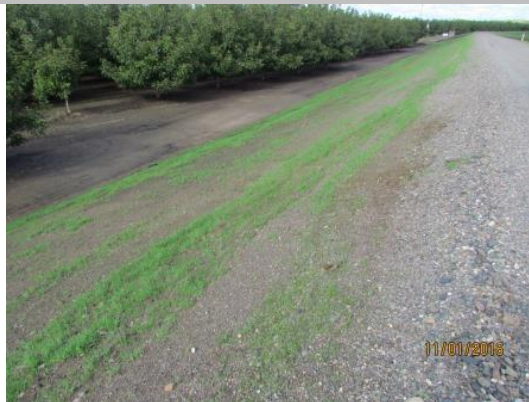
Photo 1 of 1 : SP_2017_MA0001_297_124_20170315_00053.jpg

LM Start	13.33	Rating **	M	Issue No.	124
LM End	13.33	Issue Type +	Ma	Location *	LS
Category	Earthen Levee			GPS Latitude/Longitude	
				Start	End
Item	Slope Stability			39.365748 °	39.365748 °
				-122.015633 °	-122.015633 °
DWR ID	DWR_MA0001_01_s_2017_124				
Comment Code					
S3 : Repair the levee slope damaged by vehicle traffic and prevent access where possible.					
Inspector Comment

View of the slope instability caused by vehicles along the landside slope.

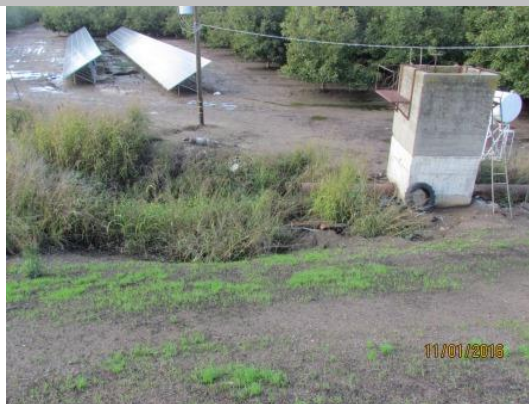
Photo 1 of 1 : SP_2017_MA0001_297_125_20170315_00054.jpg

View of the landside toe erosion caused by ag pipe.

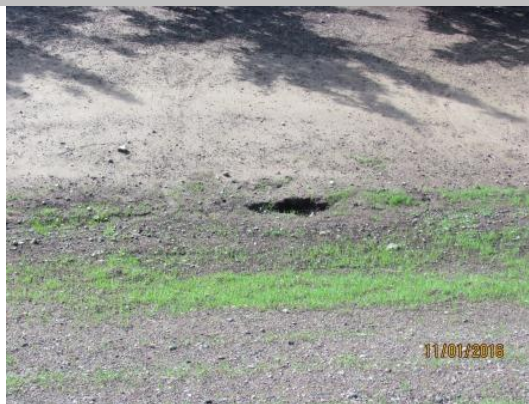
Photo 1 of 1 : SP_2017_MA0001_297_127_20170315_00056.jpg

LM Start	14.18	Rating **	M	Issue No.	127
LM End	14.18	Issue Type +	Ma	Location *	LS
Category	Earthen Levee			GPS Latitude/Longitude	
				Start	End
Item	Slope Stability			39.377288 °	39.377288 °
				-122.012360 °	-122.012360 °
DWR ID	DWR_MA0001_01_f_2016_127				
Comment Code					
S1 : Repair slope instability.					
Inspector Comment					
Minor sinkhole on the landside toe.

View of a small sinkhole along the levee.

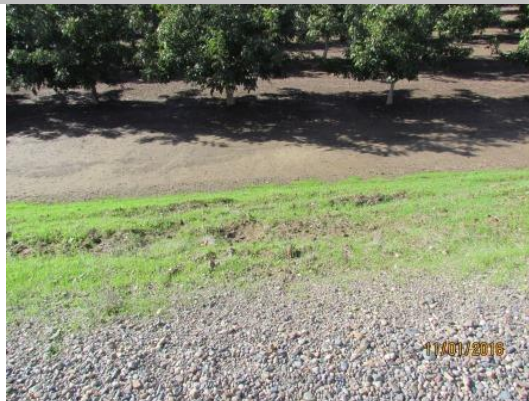
Photo 1 of 1 : SP_2017_MA0001_297_129_20170315_00058.jpg

LM Start	14.80	Rating **	M	Issue No.	129
LM End	14.80	Issue Type +	Ma	Location *	LS
Category	Earthen Levee			GPS Latitude/Longitude	
				Start	End
Item	Slope Stability			39.386008 °	39.386008 °
				-122.014270 °	-122.014270 °
DWR ID	DWR_MA0001_01_f_2016_129				
Comment Code					
S3 : Repair the levee slope damaged by vehicle traffic and prevent access where possible.					
Inspector Comment

View of the slope instability caused by vehicles along the landside slope.

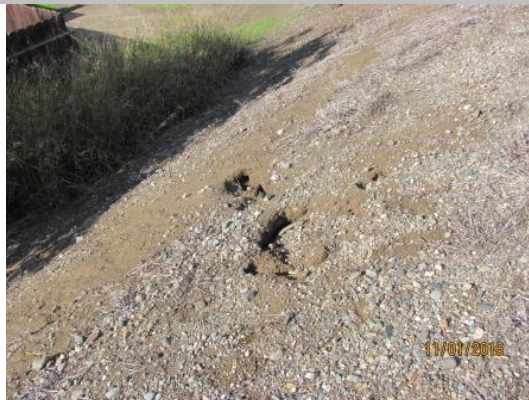
Photo 1 of 1 : SP_2017_MA0001_297_132_20170315_00060.jpg

View of the rodent holes along the landside slope.

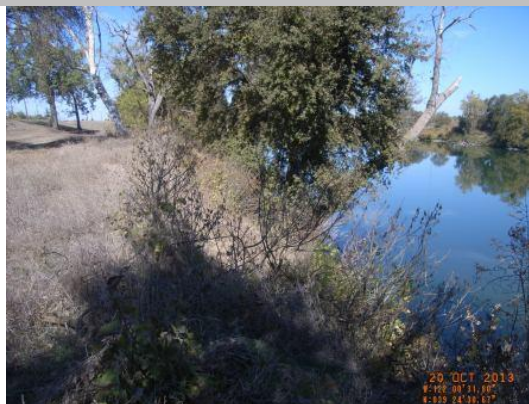
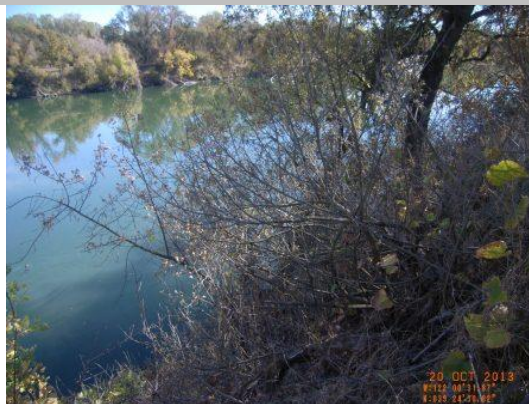
LM Start	16.35	Rating **	M	Issue No.	9
LM End	16.58	Issue Type +	Ma	Location *	WS
Category	Supplemental			GPS Latitude/Longitude	
				Start	End
Item	2015 USACE Erosion Survey, DRAFT			39.407837 °	39.411111 °
				-122.008763 °	-122.009238 °
DWR ID	DWR_MA0001_01_s_2016_9				
Comment Code					
Inspector Comment					
Erosion site added in 1997 and removed in 2005. 2009 - Site added back in, hard toe with slow moving erosion. Potential geotechnical failure. 2011 - Site extended downstream. 2015: Last observed in 2013. [2015 Site ID: SAC_164-3_R]
